St. Michael's Drive (NM 466)[®]& NMRai Runner Crossing (NMRX) / Santa Fe Rail Trail Crossing Roadside Safety Audit (RSA) FINAL REPORT October 2014

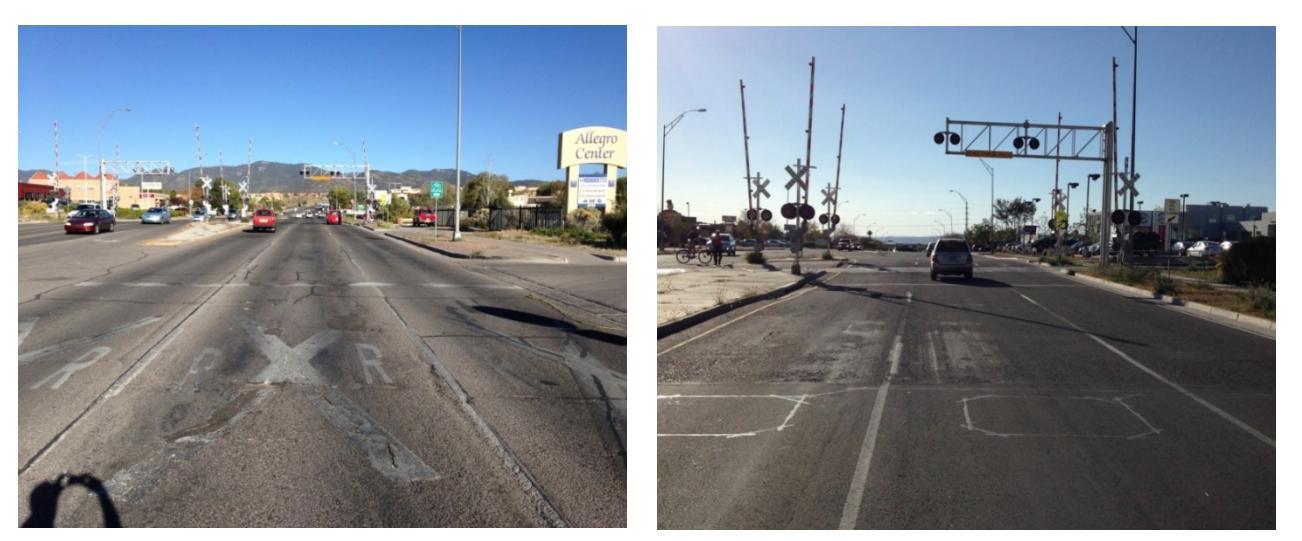
Figure 2.1 St. Michael's Drive Existing Typical Sections

Within the study area, St. Michael's Drive is a six-lane facility and approximately 130' in width (back of sidewalk to back of sidewalk based on field measurements) consisting of 6-12' driving lanes (3 lanes in each direction), 24' raised median separating east/west bound lanes, 24" curb/gutter, 8' landscaped area (8') and 6' sidewalks. Posted speed limit is 40 mph within the project area.

Eastbound St. Michael's Drive Approaching NMRX Crossing

Westbound St. Michael's Drive Approaching NMRX Crossing

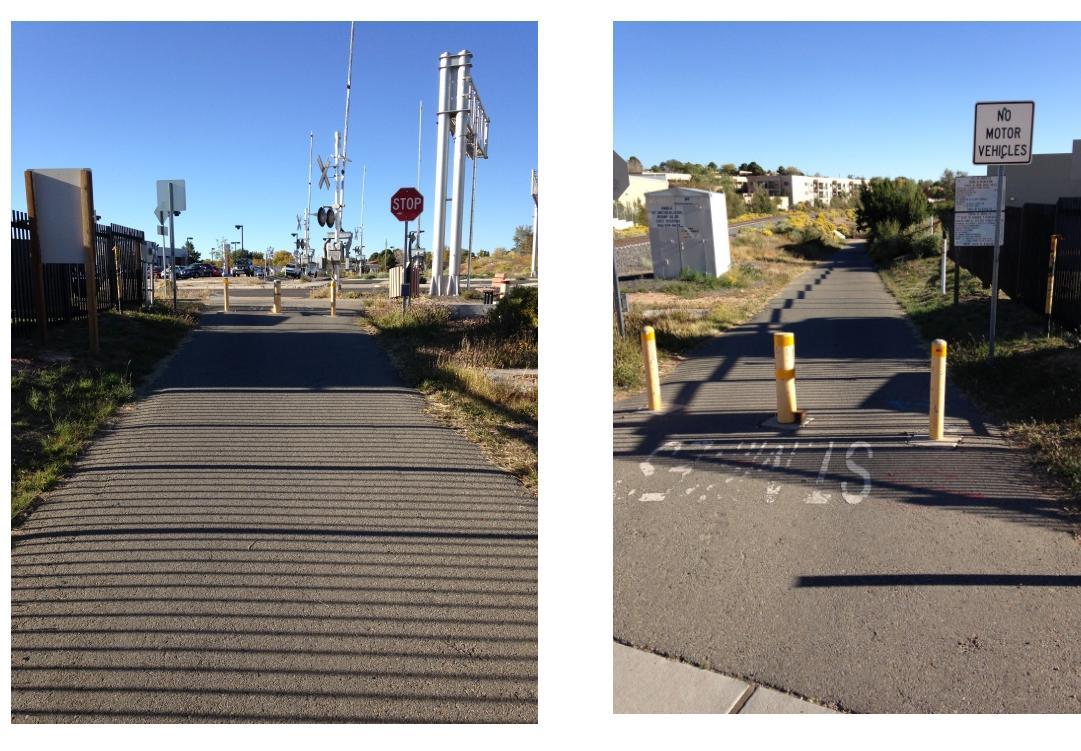
Figure 2.2 Santa Fe Rail Trail south of St. Michael's Drive

Within the project study area, SFRT is approximately 12' in width on both sides of the St. Michael's Drive crossing. Figures 2.2, 2.3 and 2.4 below represent photos of the trail south and north of St. Michael's Drive.

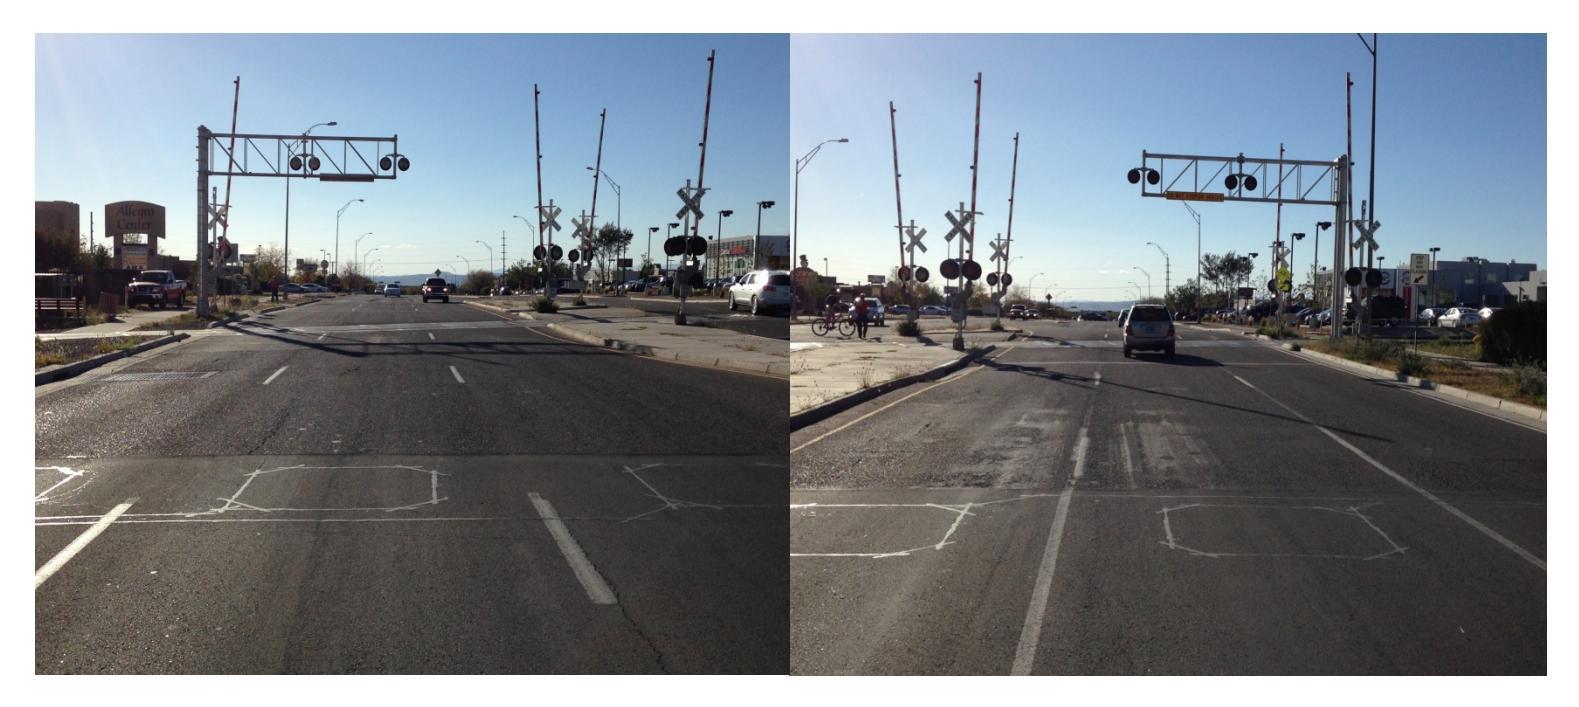
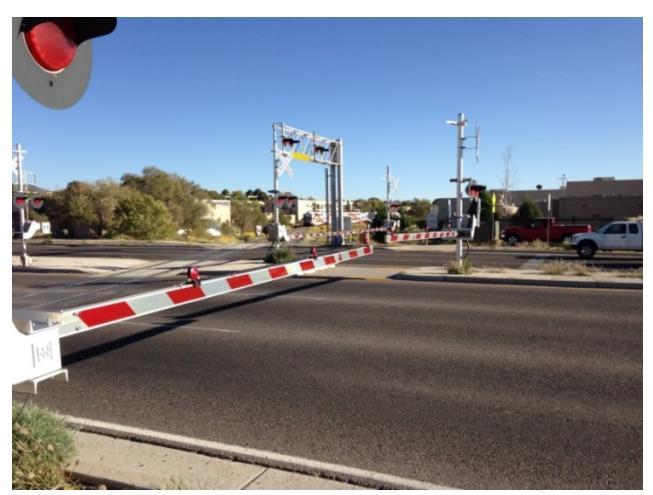
Figure 2.5 St. Michael's Drive Rail Crossing Traffic Control

St. Michael's Drive and NMRX / SFRT crossing is currently controlled by a railroad crossing. Figure 2.5 below shows three (3) photos identifying the rail crossing traffic control for both eastbound and westbound St. Michael's Drive. This crossing has a railroad signal mastarm with two (2) signal heads and six (6) crossing gates, four (4) crossing gates are for westbound traffic and two (2) crossing gates are for eastbound traffic. This crossing is considered a quiet zone crossing meaning that approaching trains do not sound the horn. There are no crossing gates to stop pedestrian/bicyclist traffic traveling along the sidewalks on St. Michael's Drive from crossing NMRX tracks.

Eastbound St. Michael's Drive Approaching NMRX Crossing Westbound St. Michael's Drive Approaching NMRX Crossing

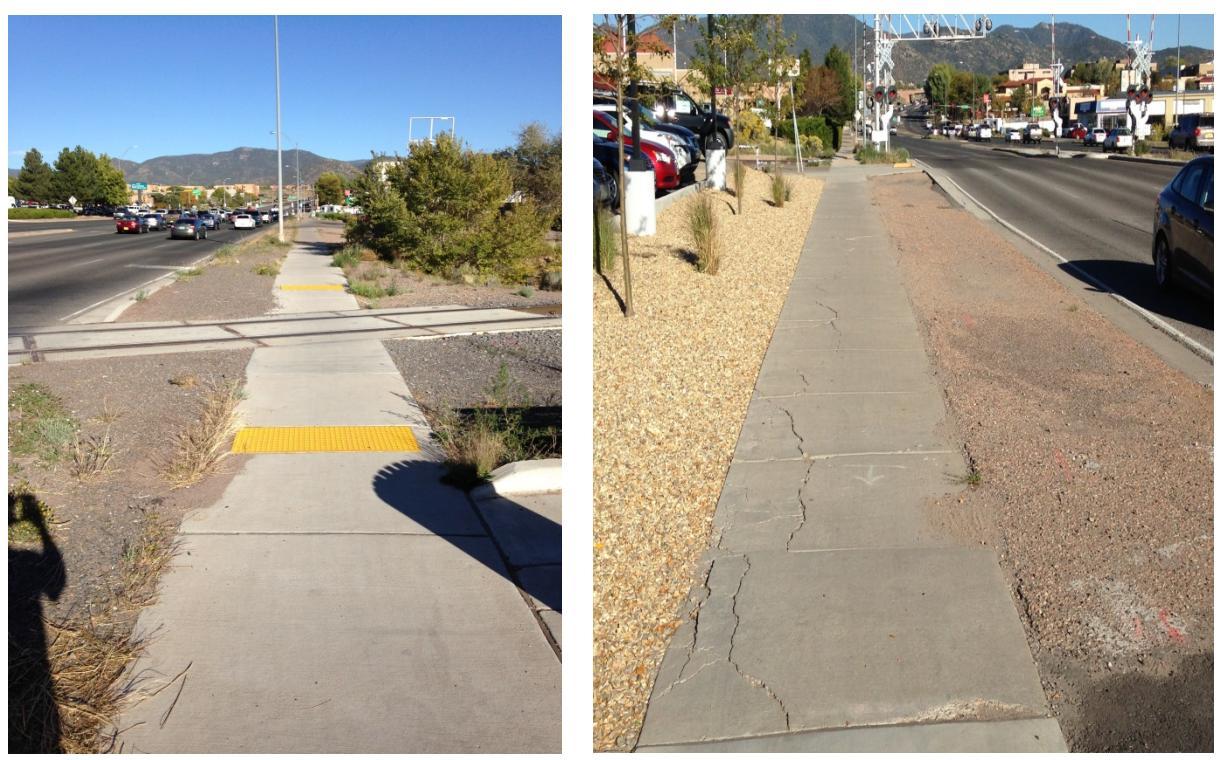
Figure 2.6 Pedestrian Facilities along St. Michael's Drive at Santa Fe Rail Trail

Pedestrian facilities within the project area are 6' sidewalks located on both the north and south sides of St. Michael's Drive.

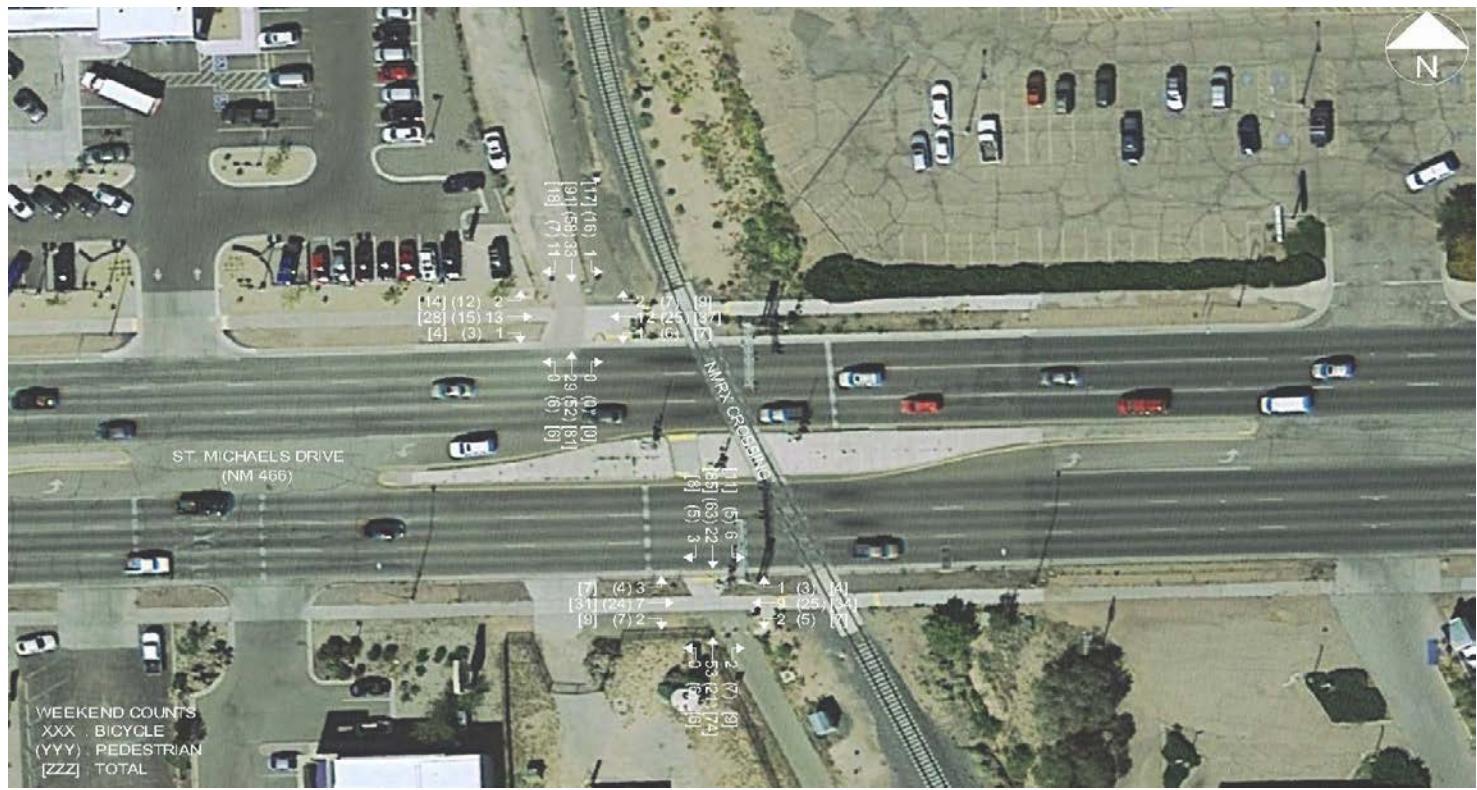
Figure 3.1 Weekday Pedestrian / Bicycle Turning Movement Counts

Turning movement counts (bicycles and pedestrians) were taken on both the north and south of St. Michael's Drive at the NMRX/SFRT crossing. Figures 3.1 and 3.2 on Page 10 identify the locations of weekday and weekend turning movement counts. All approaches of the trail at the crossing were counted.

For both the AM and PM peak hours, pedestrian/bicycle use along the SFRT is predominantly in a north/south direction.

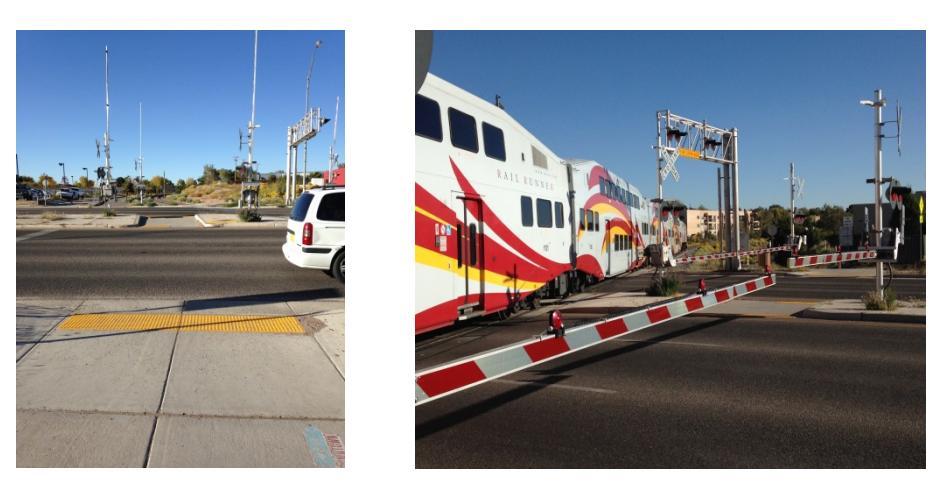
Figure 4.1 Median Refuge

One concern that has been voiced by the general public to NMDOT, City and MPO staff pertains to the median refuge for this crossing is located behind the crossing gate on the west side of the NMRX crossing. As stated previously in the report, this rail crossing was upgraded as a part of the New Mexico Rail Runner – Phase II project back in 2009. The location of the median refuge behind the crossing gates creates a safety hazard for both pedestrians and bicyclists. When a train approaches the crossing, the gates are lowered and pedestrians/bicyclists traveling northbound on the SFRT are caught in between the gates and the train and are not able to continue north until after the train has cleared the crossing and the gates are in the upright position.

Please see Figure 4.1 below showing the median refuge behind the crossing gates along the west side of the crossing.

A solution to this condition would be to construct a new median refuge approximately 25' west of its current location. By relocating the median refuge outside of the crossing gates will allow pedestrians/bicyclists to cross St. Michael's Drive unobstructed in both directions while the train crosses the St. Michael's Drive and vehicle traffic is stopped. Also by relocating this median refuge from its current location will significantly reduce any chances of a train versus pedestrian/bicyclists incident.

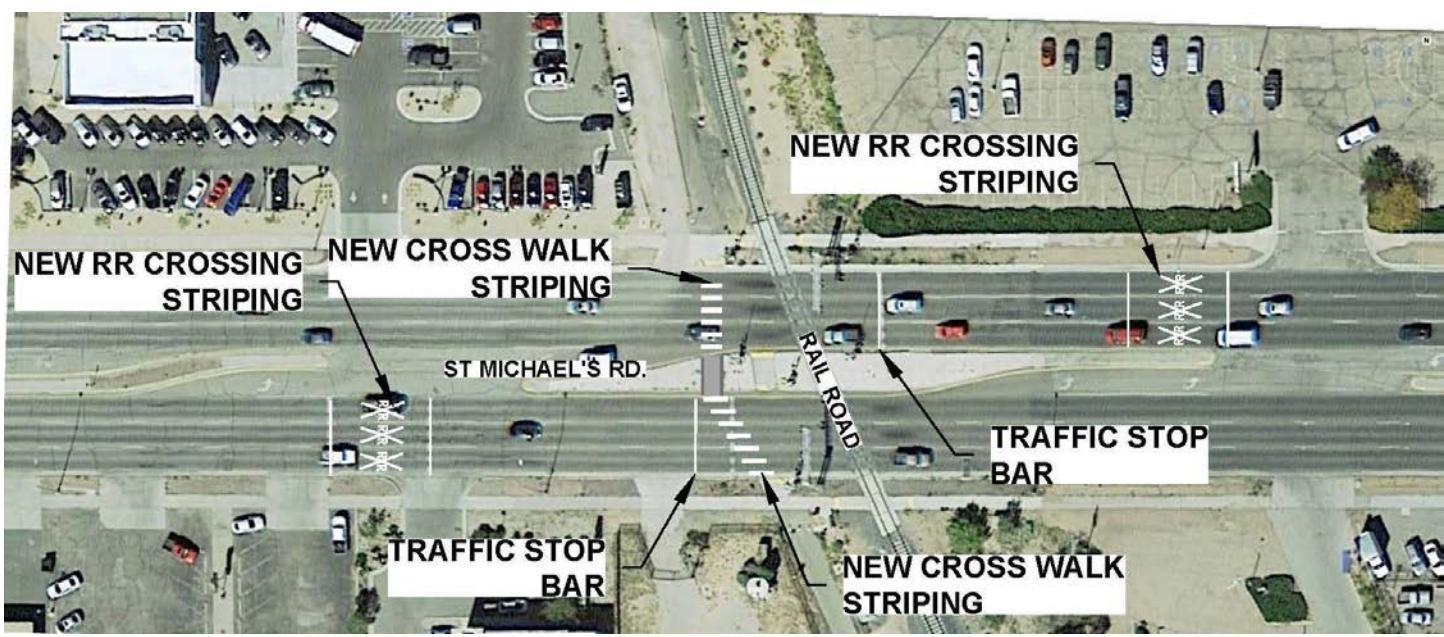
Figure 4.2 Alternative #1

Please refer to Figure 4.2 on Page 18 for a schematic drawing showing the proposed new median refuge location.

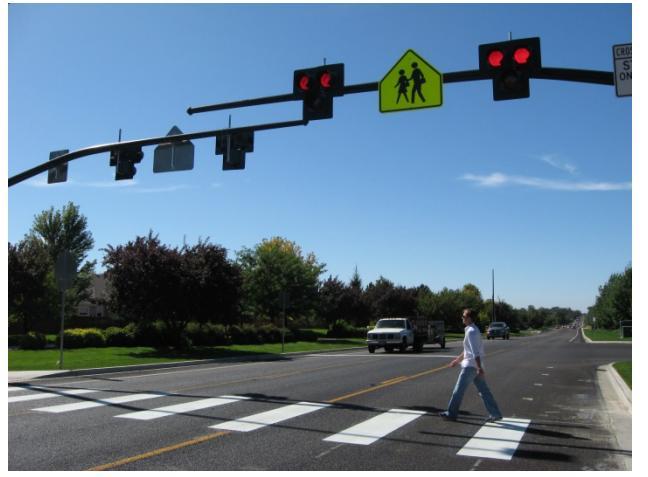
Figure 4.3 PHB Signal Head and Sign Configuration

A **P**edestrian **H**ybrid **B**eacon – PHB (formerly known as **H**igh-Intensity **A**ctivated **C**ross**W**al**K** – HAWK Signal) is a special type of hybrid beacon used to warn and control traffic at an unsignalized location to assist pedestrians crossing a street or highway at a marked crosswalk. When activated, the PHB uses a red indication to inform drivers to stop, thereby creating a time period for pedestrians to cross the major roadway. Figure 4.3 below shows an example of the current head configuration for the PHB.

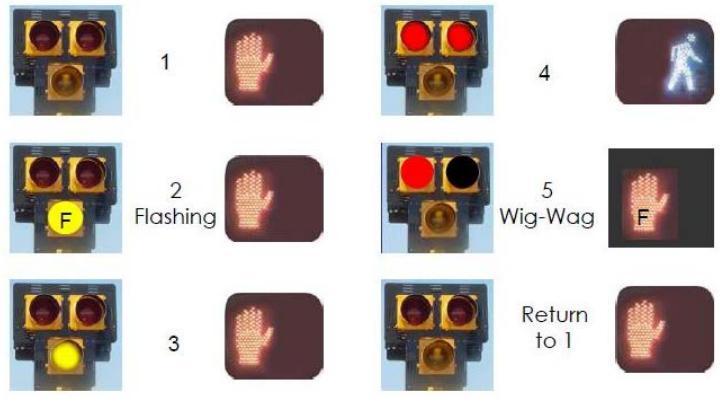
Figure 4.4 PHB Beacon and Pedestrian Signal Indications

The PHB beacon is not illuminated until it is activated by a pedestrian, triggering the warning flashing yellow lens on the major street. After a set amount of time, the indication changes to a solid yellow light to inform drivers to prepare to stop. The beacon then displays a dual solid red light to drivers on the major street and a walking person symbol to pedestrians. At the conclusion of the walk phase, the beacon displays an alternating flashing red light, and pedestrians are shown an upraised hand symbol with a countdown display informing them of the time left to cross. During the alternating flashing red lights, drivers can proceed after coming to a full stop and checking that pedestrians have already crossed

The alternating flashing red phase allows the driver delay to match the actual crossing needs of the pedestrian. Drivers can proceed with a stop-and-go operation during the flashing red phase if a pedestrian walks faster than the assumed walking speed and clears the lanes or roadway, as appropriate. If pedestrians need more time, then the drivers remain stopped until they finish crossing. The ability to balance the needs of the pedestrians with driver delay is a valuable component of the PHB treatment. Concerns have been expressed regarding driver behavior and understanding of the dark phase (not illuminated) and the flashing red phase. Figure 4.4 below shows a PHB Beacon and Pedestrian Signal Indication.

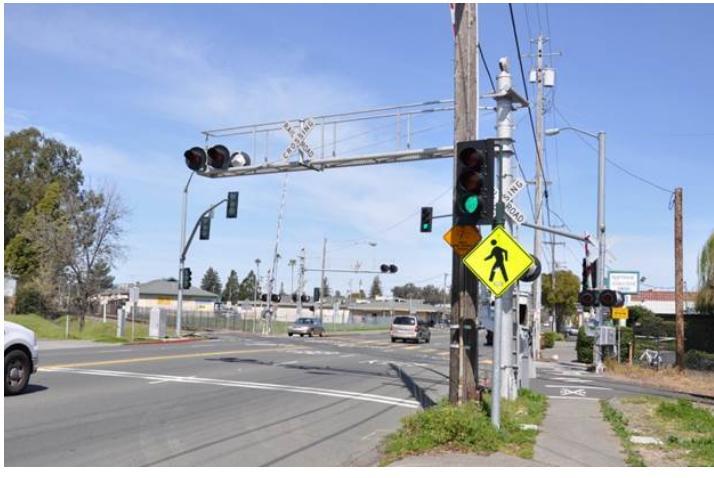
Figure 4.5 North Bound Jefferson Street approaching Napa Wine Train Crossing

Pedestrian Road Safety Audit Guidelines and Prompt List, etc.), as well as searching for locations where PHB and train signals operate together, there appears to not be a condition/location anywhere in the United States where a PHB has been installed in the same location. One location where there is full pedestrian traffic signal in conjunction with a railroad crossing is in Napa, California. The location is along Jefferson Street in Napa, California. Please refer to Figure 4.5 below showing this crossing.

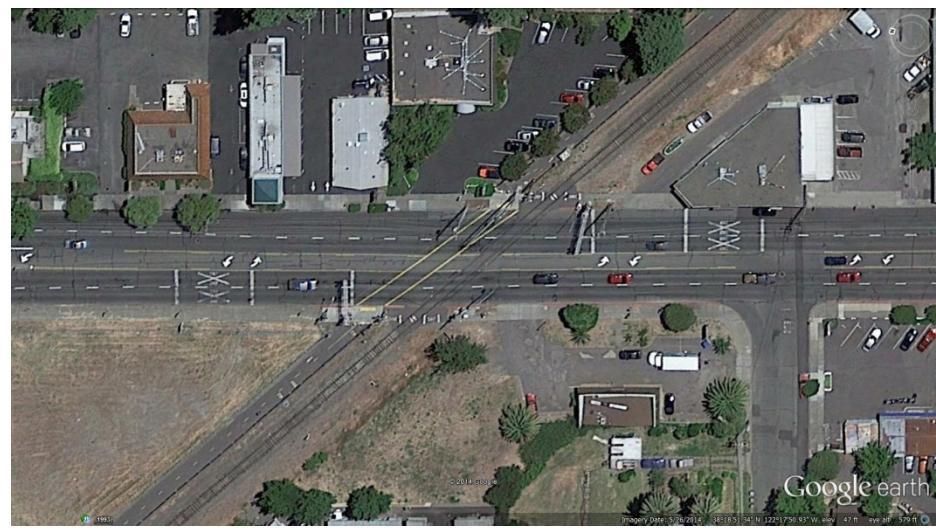
Figure 4.6 Aerial Image of Jefferson Street/Napa Wine Train Crossing

The Napa Valley Wine Train provides a three-hour, thirty-six mile round-trip journey from the historic town of Napa, through one of the world's most known wine valleys to the quaint village of St. Helena, and back. This crossing has a full traffic signal and not a PHB signal. In Figures 4.5, 4.6 and 4.7, the rail signal mastarms are placed in advance of the traffic signal mastarms at the rail/trail crossing. The traffic signals are placed on the opposite side of the rail crossing as to not to interfere with the rail signal mastarm and indications. When activated (with rail signal or traffic signal), traffic is stopped in advance of the rail crossing.

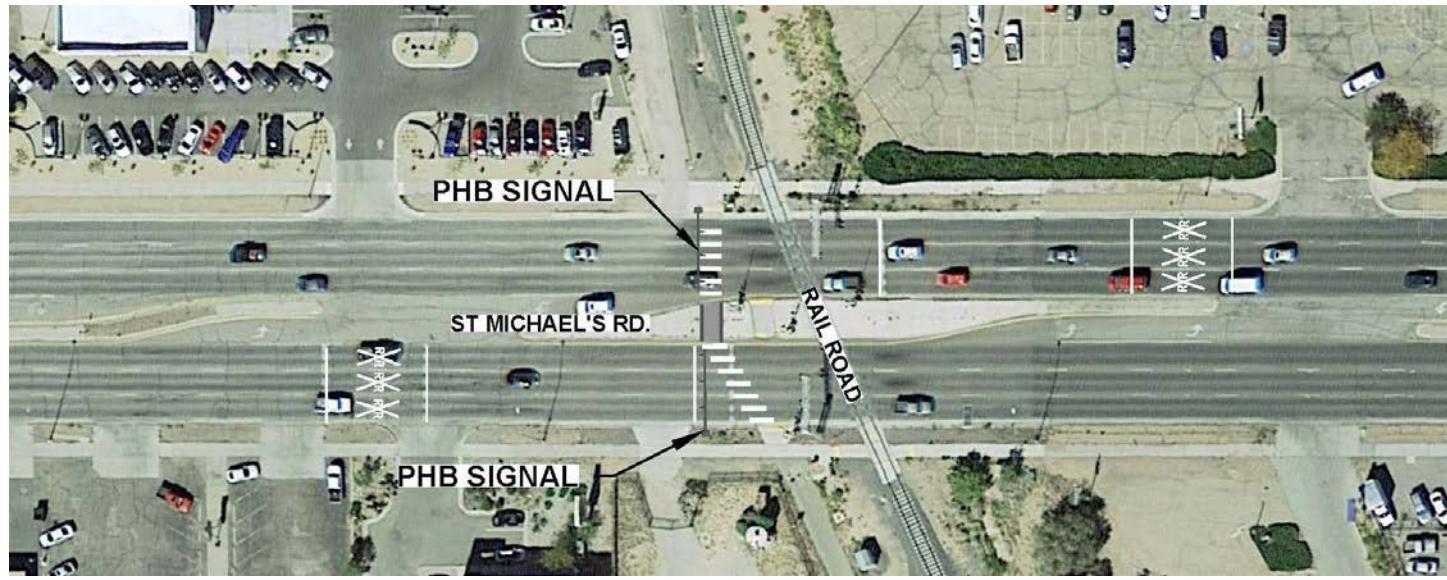
Figure 4.8 NMRX/SFRT Crossing Schematic Layout

For a PBH signal to operate at the NMRX/SFRT crossing as to provide safe travel for pedestrians/bicyclists across St. Michael's Drive as well as to not interfere with the NMRX crossing signal and operations would require placing the PHB on the west side of the NMRX crossing in conjunction with the median improvements identified in Alternative #1. With this installation, eastbound St. Michael's Drive would require adjusting the STOP bar and railroad striping back as to stop traffic in advance of the crosswalk. This would also require traffic to stop at this location when the railroad crossing is active. For westbound St. Michael's Drive, the STOP bar railroad striping would not be affected and could remain at their current location. As a part of operations, it will be critical for the PHB signal to be interconnected with the railroad crossing. Please refer to Figure 4.8 below showing a schematic layout for this alternative.

This would be similar to when a signalized intersection and a railroad crossing must function together. In this situation, when there is no train approaching a crossing, traffic signal operations for the intersection continue to operate under normal conditions. When a train is approaching a crossing, railroad crossing gates and flasher activate and the traffic signal controller stops vehicular traffic from entering the railroad crossing. Once the train clears the crossing, the intersection traffic signal goes back to normal operations. Under this alternative with a PHB operating in conjunction with a railroad crossing, as a train approaches the crossing, the PHB signals would not operate until after the train clears the crossing. Since the pedestrian/bicycle crossing itself does not interfere with the railroad crossing, when a train is approaching the crossing and vehicular traffic is stopped, pedestrian/bicycle traffic could still safely cross St. Michael's Drive.

With the installation of a PHB, traffic operations along St. Michael's Drive may be impacted. When a pedestrian activates a PHB, travel time to cross St. Michael's Drive is estimated to be 28 seconds per crossing. During peak hours, travel time delays for vehicular traffic along St. Michael's Drive based on pedestrian crossings will be approximately 17 minutes (average delay per vehicle) during the AM peak and 23 minutes during the PM peak hours. These potential delays during the peak hours could cause traffic along St. Michael's Drive to queue back to the traffic signal at Calle Lorca (approximately 580' east) as well as 5th Street.

Further analysis of this alternative should be conducted using micro-simulation software with more up to date AADT data along St. Michael's Drive to evaluate the following:

- Spacing of Signals
- Queuing/Signal Timing
- Integration with Train Signal
- Potential confusion between Train Flashers and PHB Flashers
- Vehicles stopping on the tracks

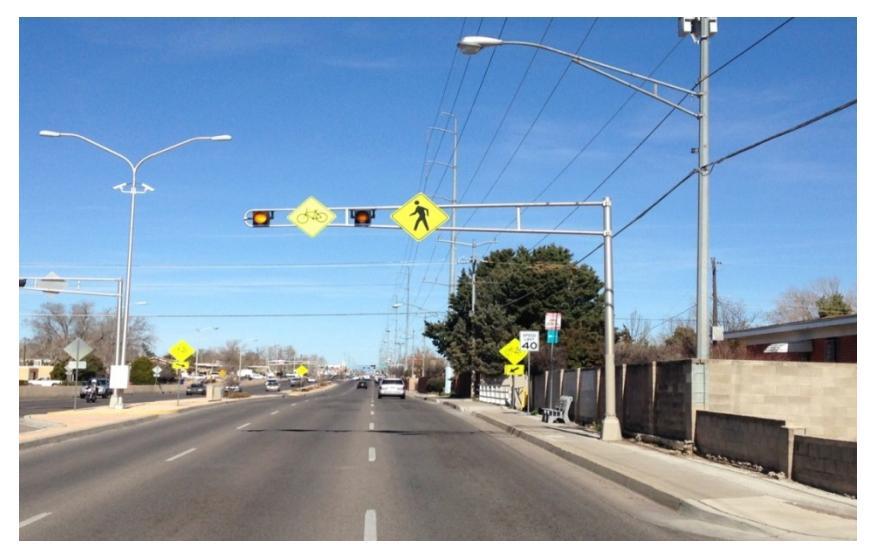
Figure 4.9 Type II Mastarm with Flashers and Pedestrian/Bicycle Signage

Location of the Type II mastarms would be approximately 300' away from the crossings with additional W11-15 and W16-7PL/W16-7PR signs mounted at the locations of the crosswalks.

Figure 4.9 below shows the advanced flasher with appropriate MUTCD signing on Wyoming Boulevard just south of Indian School Road.
