Appendix D Visual Analysis of the Overcrossing at Rail Runner Loop and Camino Carlos Rey

I-25 CORRIDOR STUDY

Visual Analysis of the Overcrossings at Rail Runner Loop and Camino Carlos Rey

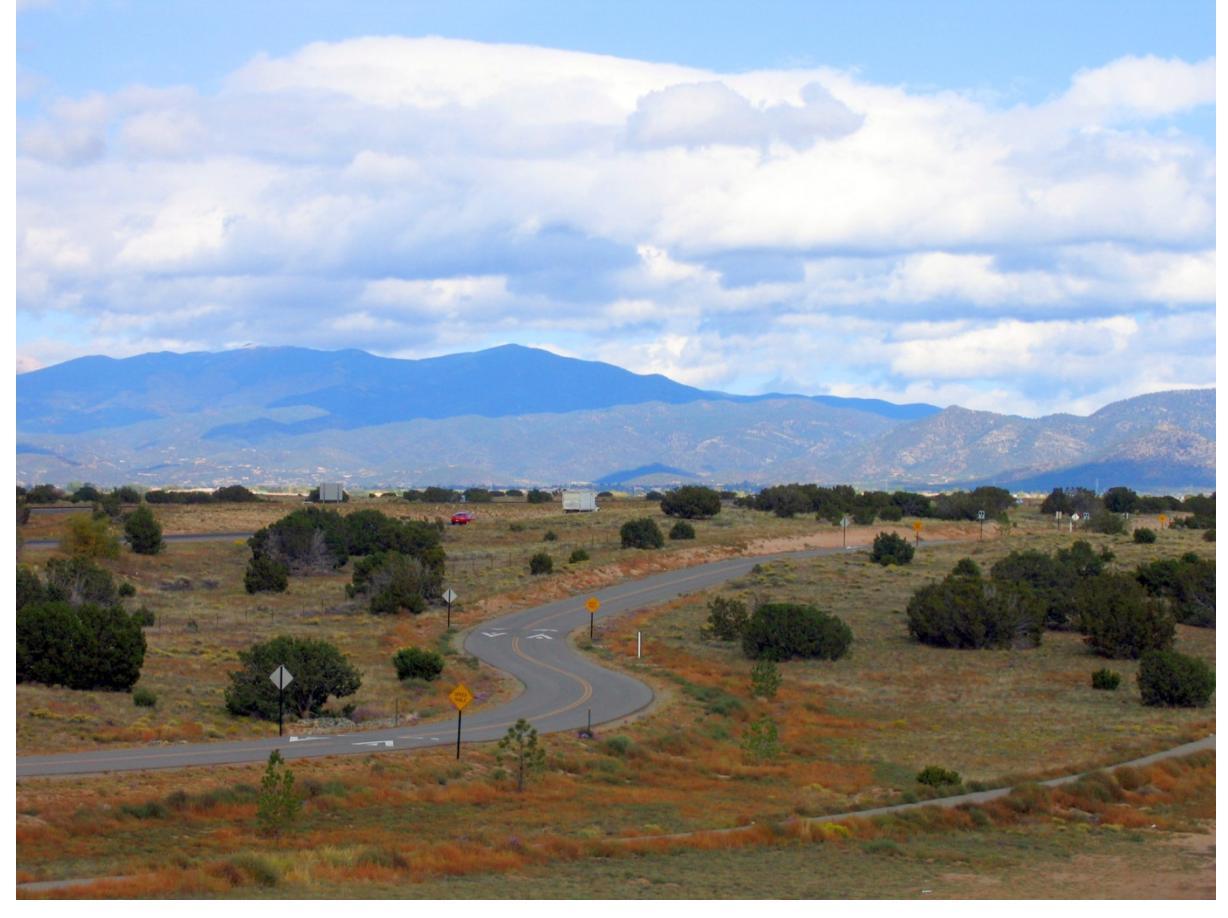
FIGURE 1

Existing View KOP 1: Rail Runner Loop (from Frontage Road at Dinosaur Trail)

The existing view of the project area is depicted in Figure 1. KOP 1 is located on Frontage Road at Dinosaur Trail, south of Interstate 25 (I-25), in an area that has little urban development. Viewer sensitivity at this location is moderate because while travel along Frontage Road provides extended views of the Sangre de Cristo mountain range, most motorists use I-25. The mountain range creates a strong horizon, and the representative southwestern vegetation, low-growing grasses and pinion pines, provides texture and color. This view has a moderately high level of vividness because of the mountain range in the distance and the vegetation in the foreground. The continuity between the foreground and background established by the vegetation creates cohesion for a moderately high level of unity. Aside from the road and traffic signs in the foreground, there are few features that encroach upon the view, providing a moderately high level of intactness. The overall existing visual quality of this view is moderately high.

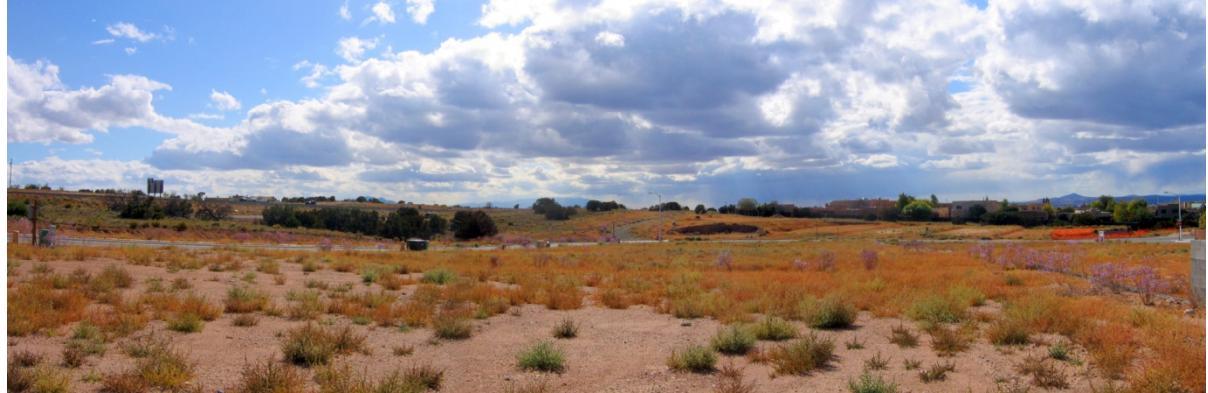
FIGURE 2

Existing View KOP 2: Camino Carlos Rey (Looking South and West towards I-25)

The existing view of the project area is depicted in Figure 2. KOP 2 is located at the southern most limits of Camino Carlos Rey looking to the south toward I-25. This location is representative of views of residents living within the Camino Carlos Rey subdivision and for motorists using Camino Carlos Rey; thus, viewer sensitivity is high at this location. From this KOP, the vegetation in the foreground and the mountain range in the far distance serve as the principle elements contributing to the view's vividness. However, the mountain range is partially screened by existing development and too distant to dominate the view, contributing to the moderately low degree of vividness. The lack of a strongly defined skyline or patterning within the built environment generates a moderately low level of cohesiveness or unity. There are few existing visual encroachments in this view for a moderately high level of intactness. Overall, the visual quality is average.

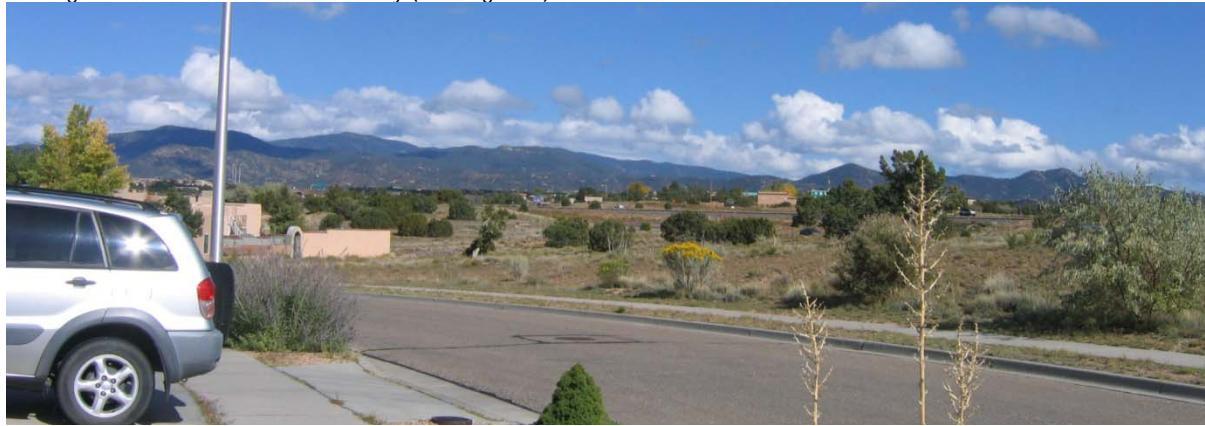
FIGURE 3

Existing View KOP 3: Camino Carlos Rey (Looking East)

The existing view of the project area is depicted in Figure 3. KOP 3 is located on Pueblo Bonito in the Pueblos del Sol residential subdivision, west of the proposed Camino Carlos Rey bridge extension. This location is representative of the view for residents in this neighborhood; thus, viewer sensitivity is high at this location. From this point, the Sangre de Cristo mountain range comprises the principal element of vividness. The prevalence of native vegetation creates screening and texture that integrates much of the built environment into the natural environment, producing an uninterrupted, continuous view from foreground to background. The vegetation and the mountain range contribute to a moderate level of vividness. Existing urban development, including light poles, traffic signs, and commercial development dilute the intactness of the view. However, existing residences incorporate architecture characteristic of Santa Fe to produce coherence between human-made and natural features. Existing overall visual quality at this location is moderate.

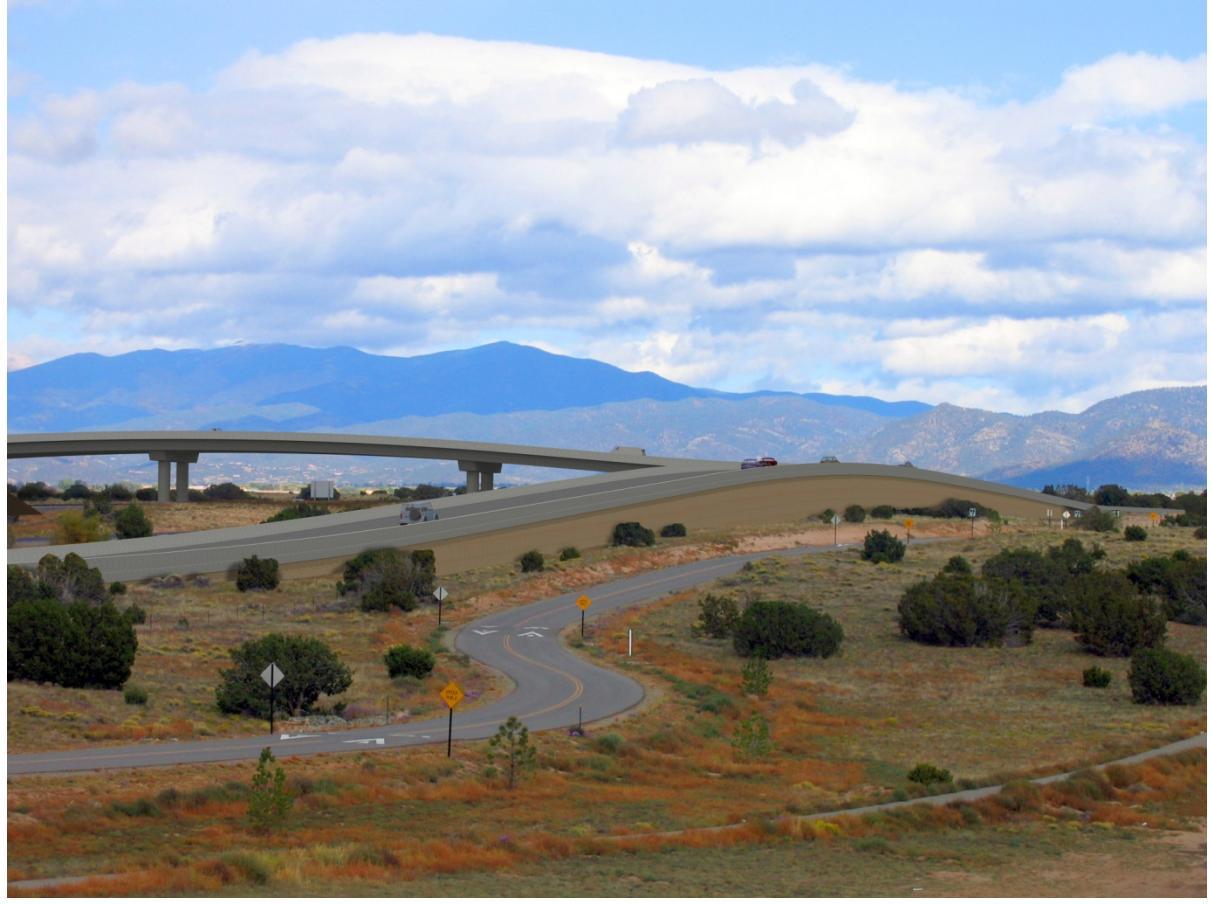
FIGURE 4

KOP 1 Simulation: Rail Runner Loop (from Frontage Road at Dinosaur Trail)

Figure 4 is a simulation of the view from KOP 1 as it would appear during the project's operational period. As review of this simulation indicates, from this observation point, the project's features would be visible. At this location, the addition of the flyover and the overpass would diminish the level of vividness by partially blocking the view of the mountain range, which is the primary element contributing to vividness. The scale of the overpass at this distance compared with the surrounding landscape dominates the view and becomes the focal point. The highway would divide the view into two distinct landscape units, with the mountains in the distance separated from the landscape in the foreground. This separation would diminish the unity, or cohesiveness, of the view. The addition of the overpass diminishes the unity and intactness. The overall visual quality at this location would decrease with the installation of the overpass from moderately high to average.

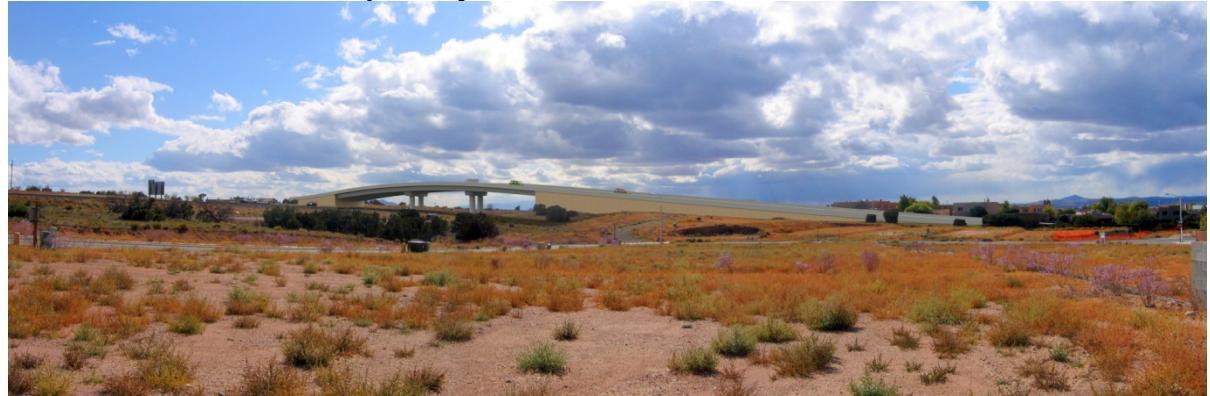
FIGURE 5

KOP 2 Simulation: Camino Carlos Rey (Looking South and West toward I-25)

Figure 5 is a simulation of the view from KOP 2 as it would appear during the project's operational period. As review of this simulation indicates, from this observation point, the project's features would be visible. Because the overpass would be backdropped against the sky, it would become the dominant visual feature in this view. The overpass would

partially block views of the distant mountain range, which would decrease the view's vividness as the mountain range is a contributing element to vividness. However, the peak shown to the right of the photo would remain visible to motorists, so vividness would remain relatively unaffected. The introduction of the highway overpass into this relatively undeveloped area would constitute a visual intrusion and would serve to diminish slightly the intactness of the view from moderately high to moderate. The highway would not disrupt the level of unity of this view because the overpass would constitute an additional horizontal feature to the horizontal patterning already present in the view. With the introduction of the roadway features into this view, the overall visual quality would be moderately low.
